## MARLBOROUGH ELEMENTARY SCHOOL FLAT ROOF SYSTEM ENGINEERING REPORT

REPORT DATE: December 12, 2006  
PROJECT NUMBER: 194

PROJECT: Flat Roof System  
Marlborough Elementary School  
23 School Street  
Marlborough, New Hampshire

INSPECTION DATES:	November 8, 2006	November 13, 2006
TIME:	3:00 PM	3:00 PM
WEATHER:	Sunny, 50 degrees	Cloudy, 50 degrees

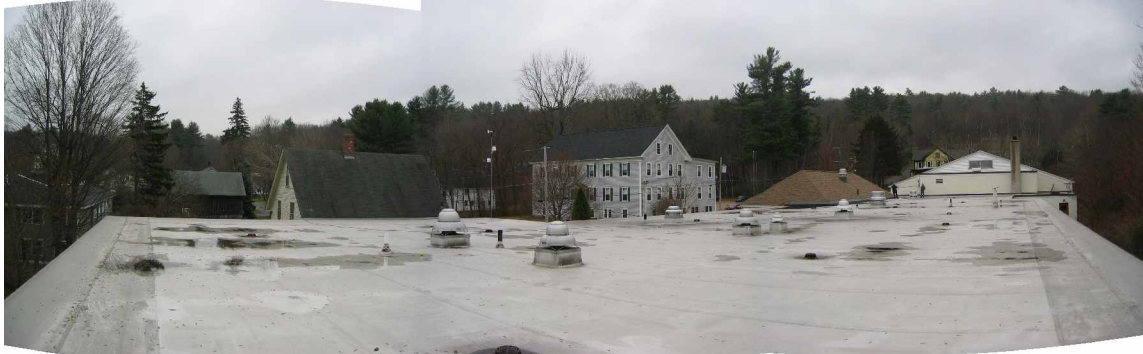
Observations made from the interior of the building did not indicate any significant deflection. The approximate deflection measured in room 214 and was found to be 1/4". Observations were also made on the exterior of the building on the flat roof. These observations were made shortly after a significant rainfall. If there was a consistent pattern of excessive deflection it would have been indicated by ponding of water on the flat roof at the mid-span of each bay. While there was a minimum amount of ponding noted there was no pattern observed. The most significant ponding was found to be 3/4" deep. GV cannot comment on why there may have been ponding in this particular area, but it is not necessarily an indication of any structural deficiency.

The attached photographs show the lack of a pattern of ponding and also show the isolated areas where ponding is occurring. Please see photographs 1, 2 and 3.

PHOTO 1 - FLAT ROOF - NOTE NO PATTERN OF PONDING

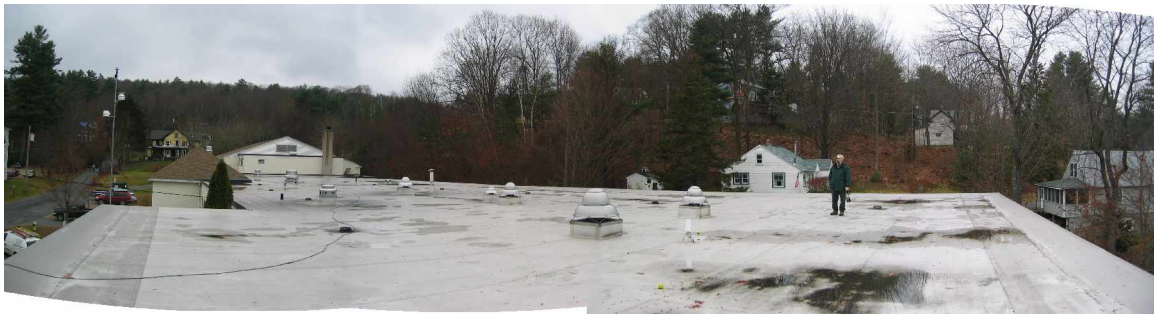
PHOTO 2 - FLAT ROOF - NOTE NO PATTERN OF PONDING

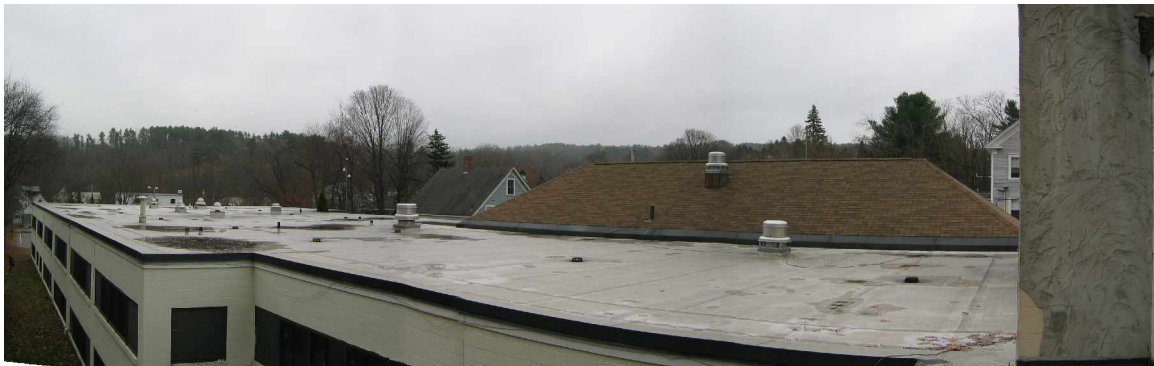
PHOTO 3- FLAT ROOF - NOTE NO PATTERN OF PONDING

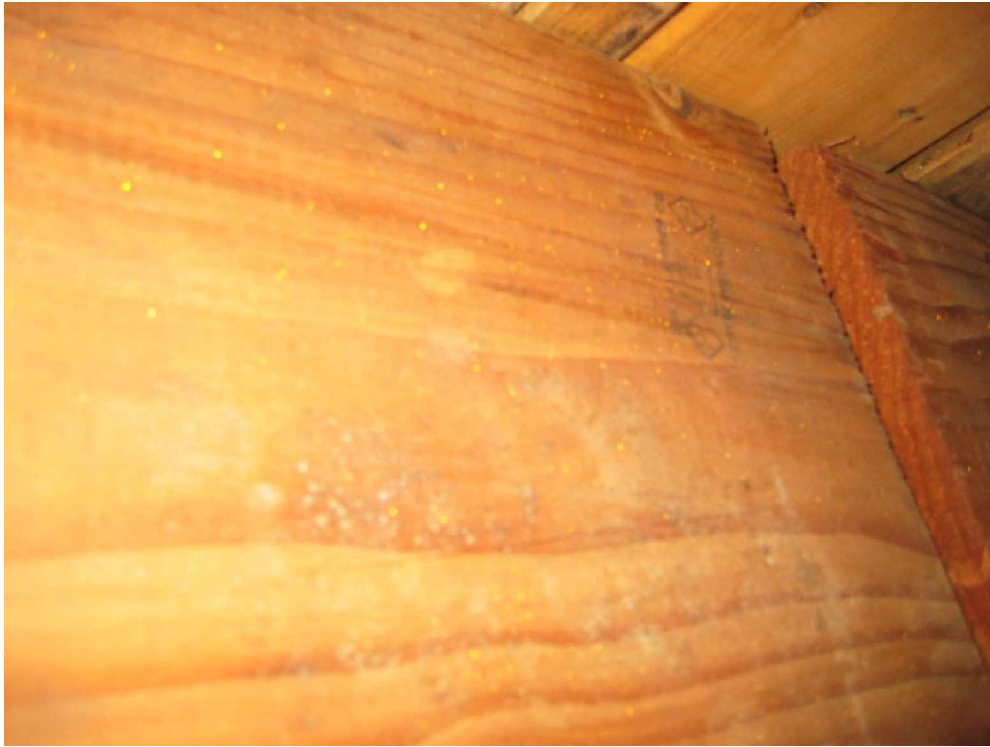
The flat roof rafters in the 1957 construction are nominal 2x14s with actual dimensions of 1-1/2"x13". The rafters are spaced at 16" on center and span approximately 23'-4". For calculation purposes GV conservatively considered the material to be # 1 Hemlock-Fir. However, it may very well be another type of wood with a higher strength. At the bearing walls between the rooms the members butt end to end. This results in a bearing on the wall of approximately 4". Please see photograph 8.

PHOTO 8 - TYPICAL END CONFIGURATION OF 1-1/2" x 13" RAFTERS

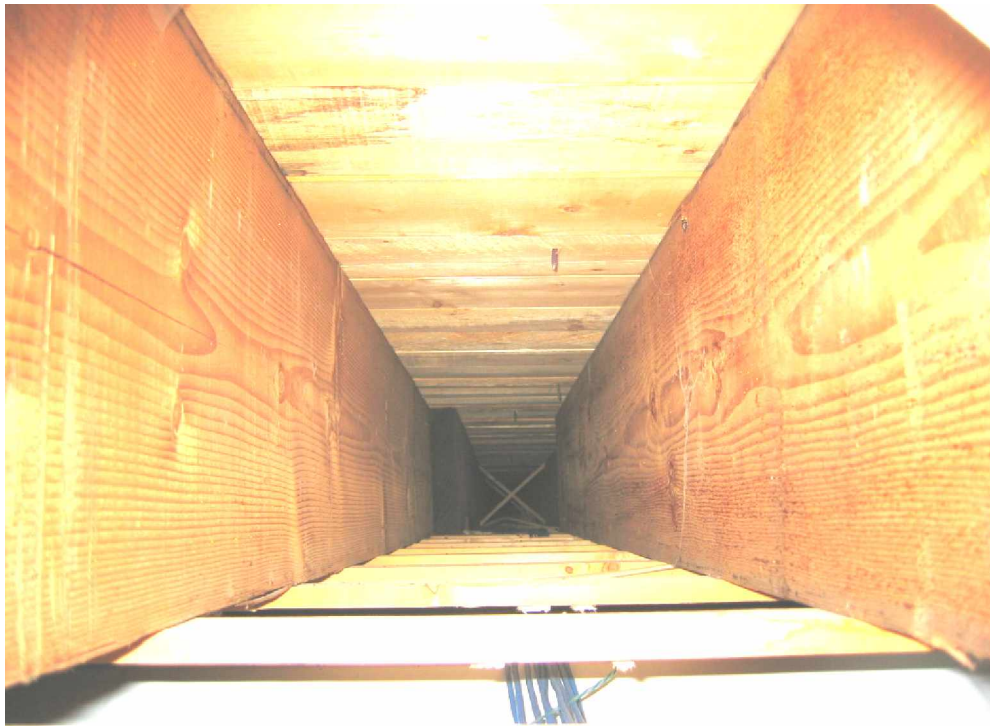
The flat roof rafters in the 1964 section of the building are nominal 3x14s with actual dimensions of 2-1/2"x13". The rafters are spaced at 16" on center and span approximately 26'-0". For calculation purposes GV conservatively considered the material to be # 1 Douglas Fir. However, it may very well be another type of wood with a higher strength. At the bearing walls between the rooms the members overlap ends. This results in a bearing on the wall of approximately 8". Please see photograph 9.

In several locations GV observed "checks" in the timbers. Please see photographs 12 and 13. Check cracks in the wood result from the expansion and contraction of the material and from the normal drying process and are not necessarily a result of overstressing. Where found, all of these checks were observed to be at approximately mid-depth of the rafters. Please see photographs 9 and 12.

PHOTO 9 - TYPICAL VIEW OF 2-1/2 x 13 RAFTERS LOOKING FROM OBSERVATION OPENING DOWN THE BAY (Room 211)  
NOTE OVERLAPPING BEARING CONDITION OF 2-1/2x13 RAFTERS

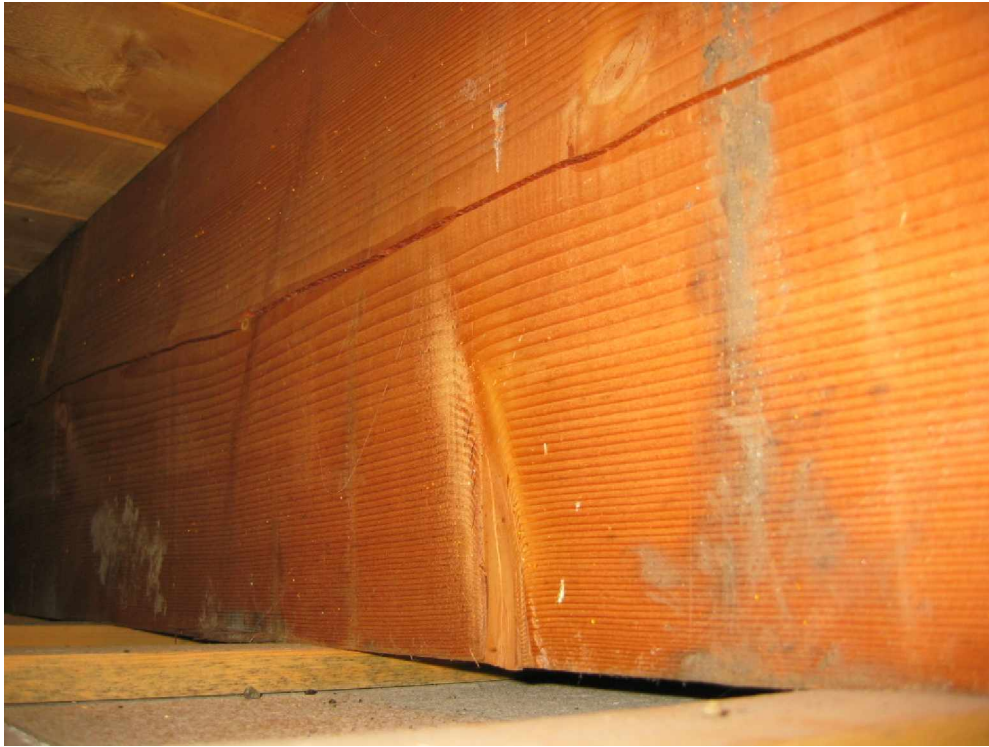
In GV's opinion the observed check cracks have little or no effect on the strength of the rafters. Any cracking resulting from overstress would have been exhibited on the bottom edge of the rafters. GV did not observe any cracks on the bottom edge of the rafters. Another indication of cracking resulting from a structural deficiency would be the presence of significant deflection. As noted above GV did not observe any excessive deflection.

PHOTO 12 - TYPICAL (WHERE FOUND) CHECK IN 2-1/2" x 13" RAFTER

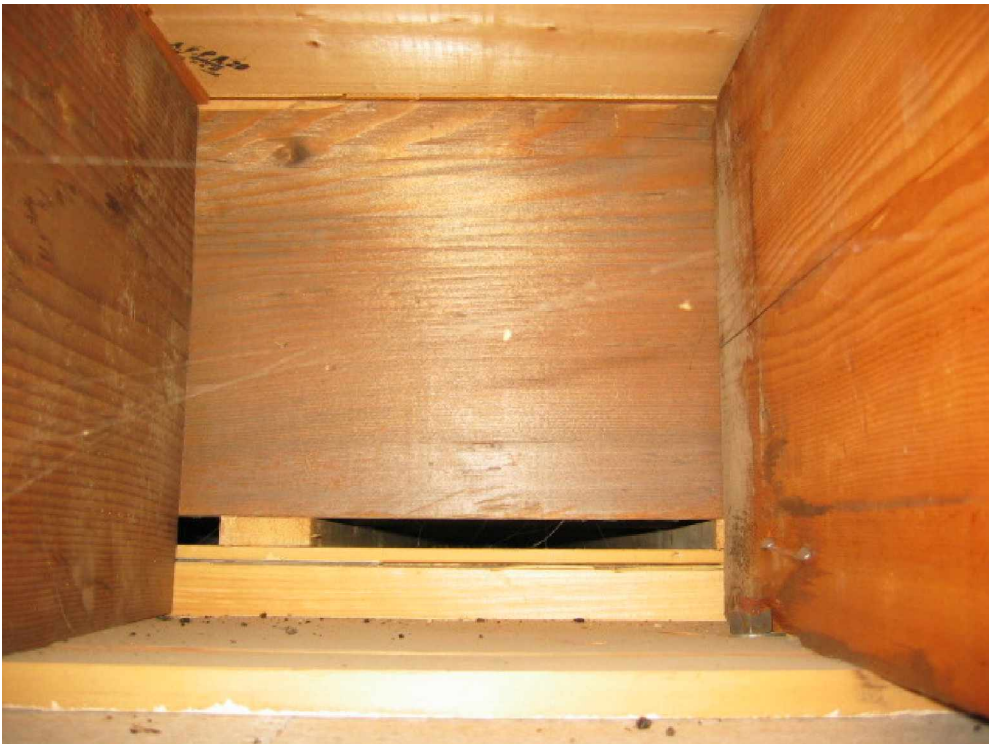
PHOTO 13 - TRANSITION FROM ROOM 217 TO ROOM 218  
DIRECTION OF SPAN CHANGES
