August 29, 2006

Ms. Karen Parsells, Principal
Marlborough School
23 School Street
Marlborough, New Hampshire 03455

Re: Playground Inspection

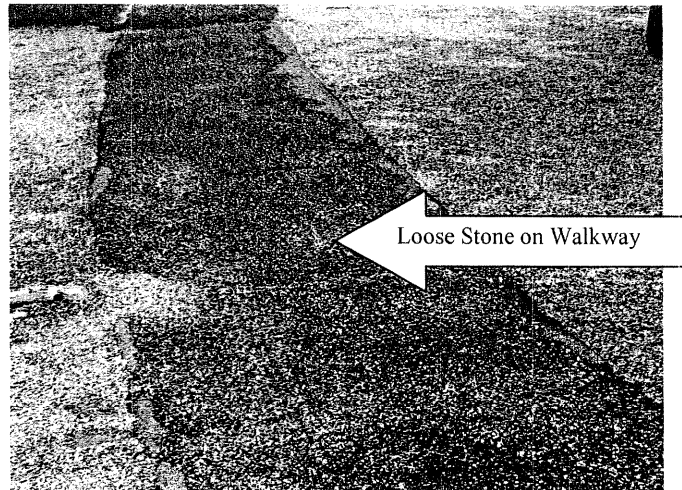
- ♦ The surfacing material (coarse gravel or pea stone) is an adequate surfacing material, however, it is not of adequate depth throughout most of the playground. The bottom portion however is somewhat compacted and needs to be turned or tilled to maintain its impact absorbing properties. The use zones (minimum of 6 feet from each piece of equipment) should be the primary focus of this activity. Care should be taken to occasionally sweep the surfacing material off of the paved walkways to minimize the risk of a slip and fall due to the loose stone on the hard surface. See table 1 on page 5 of the enclosed Handbook for Public Playground Safety.

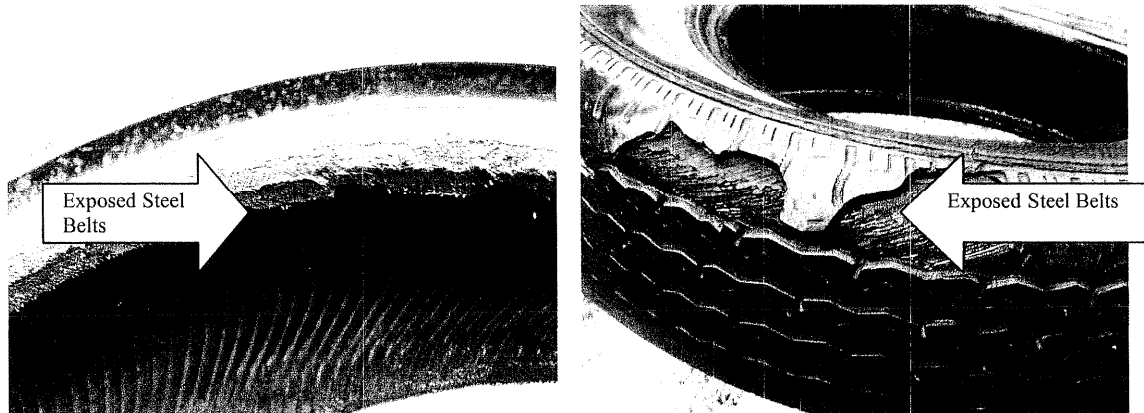
- ♦ The tire swing has several tires where steel belts are exposed creating a significant potential for a laceration. The tires should be replaced or removed immediately to minimize this risk. Additionally, the use zone around this piece of equipment is not adequate. This is one area where the surfacing material is not adequate in depth (6 inches), and there is not enough room around the swing (6 feet).

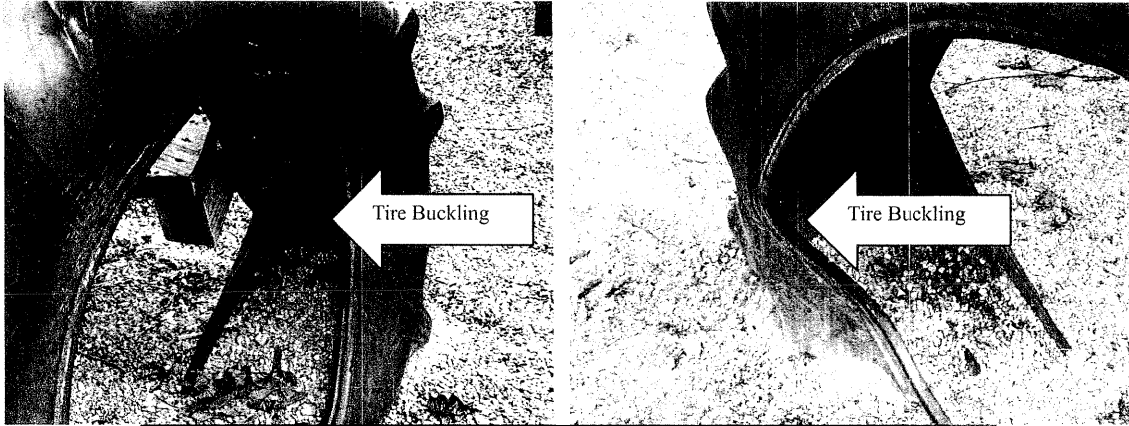
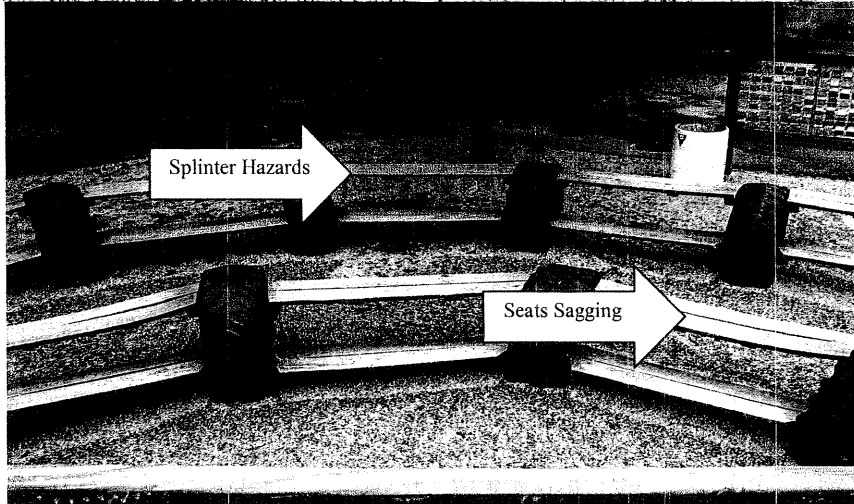
- ♦ The tires that support the amphitheater seating are weakening due to age, and are at risk of collapsing under the weight of several occupants. This is a concern since the tires are exposed underneath the seats, and a child could be inside a tire when it collapses. This structure should be removed or the tires replaced as soon as possible. There are also areas where the wood is splitting, and could break and there is a potential for splinters as well.

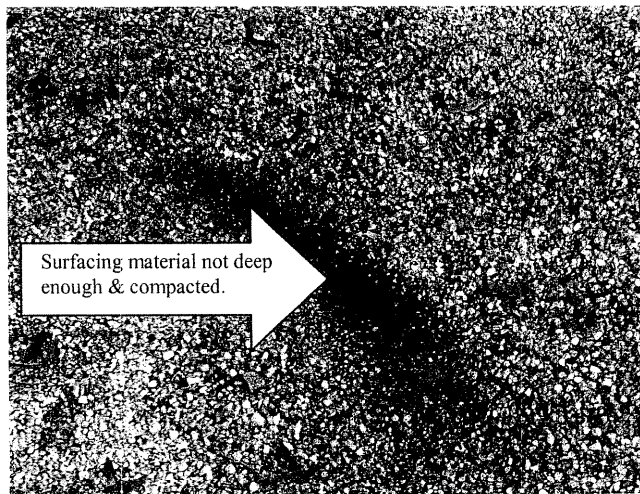
- ◆ Surfacing material needs to be added under the climbers to a depth of nine inches (9") based on the height of the climbers. The existing material should be tilled first, then additional material added to secure the proper depth.

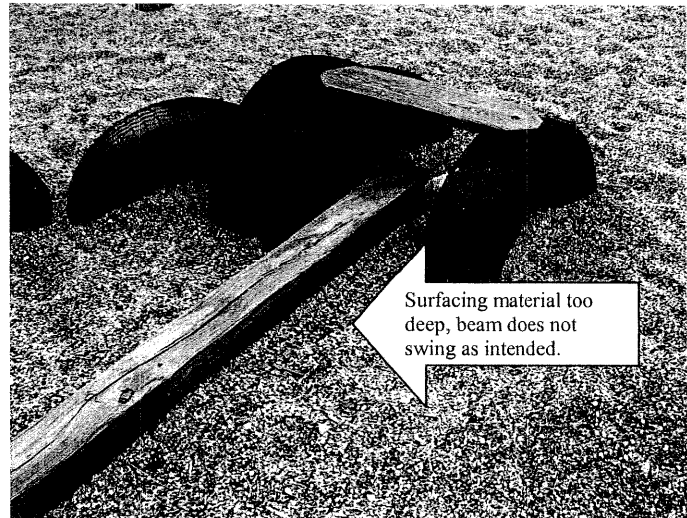
- ♦ The swinging balance beam (ground element) has too much surfacing material under it causing it to not operate properly. It is recommended that the surfacing material be removed to a depth of 5 inches under the beam to allow for the element to swing as intended.

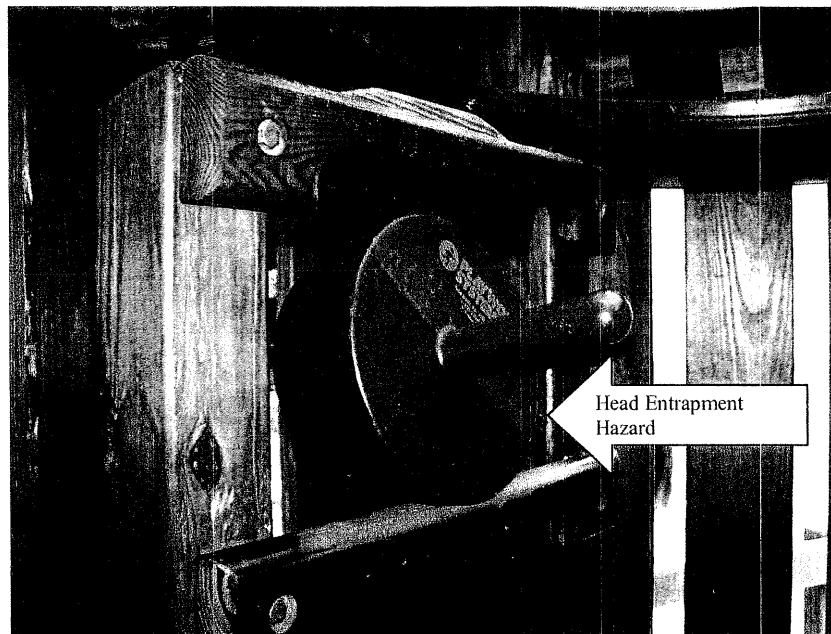
- ♦ The top step inside the castle climber is a potential head entrapment hazard due to the close spacing of the top two rungs of the ladder. It is recommended that the steps be separated to greater than nine inches (9") but not more than 15 inches (15") apart.

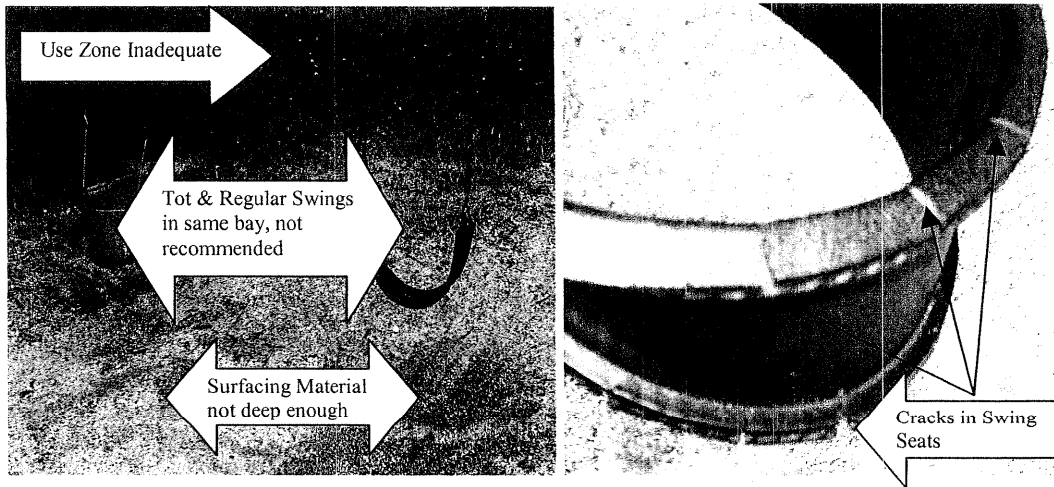
- ♦ The use zone for the swings is inadequate and should be extended to include six feet out from each end of the swing set and 20 feet in front of and behind the swings based on the 10-foot height of the pivot point. Several swing seats are cracked and should be replaced as soon as possible, and the spacing is not compliant with ASTM/CPSC Guidelines (swings should be at least 24 inches apart, and 30 inches from the swing structure). Also, tot swings are not recommended in the same bay as regular swings.

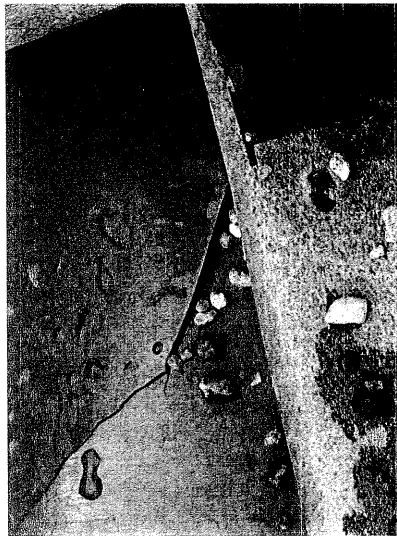
- ♦ There is a crack in the plastic at the top of the slide that should be repaired immediately to prevent the risk of an entanglement hazard.
