Marlborough Elementary School Information Campaign

Building Assessment and Feasibility Study

THE MARLBOROUGH BLUEPRINT

Weller & Michal Architects Inc.

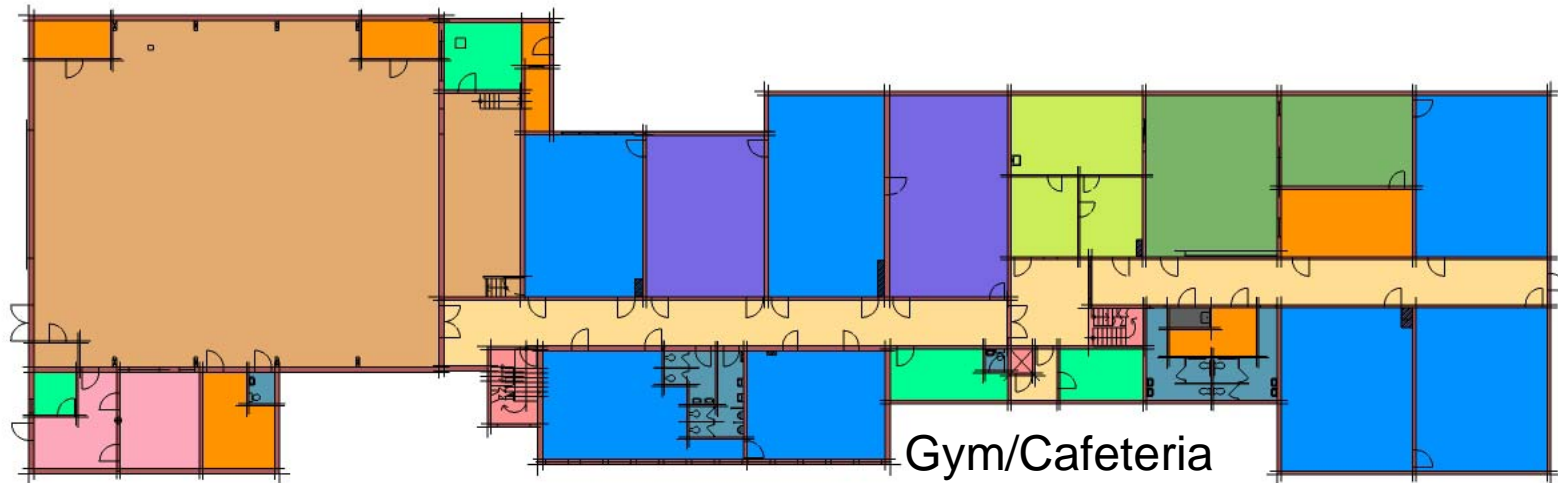
Existing Upper Level Plan

- Gym/Cafeteria
- Kitchen
- Math
- Grades 4 thru 8
- Library
- Science
- Computer Lab
- Teacher Work Room
- Counseling

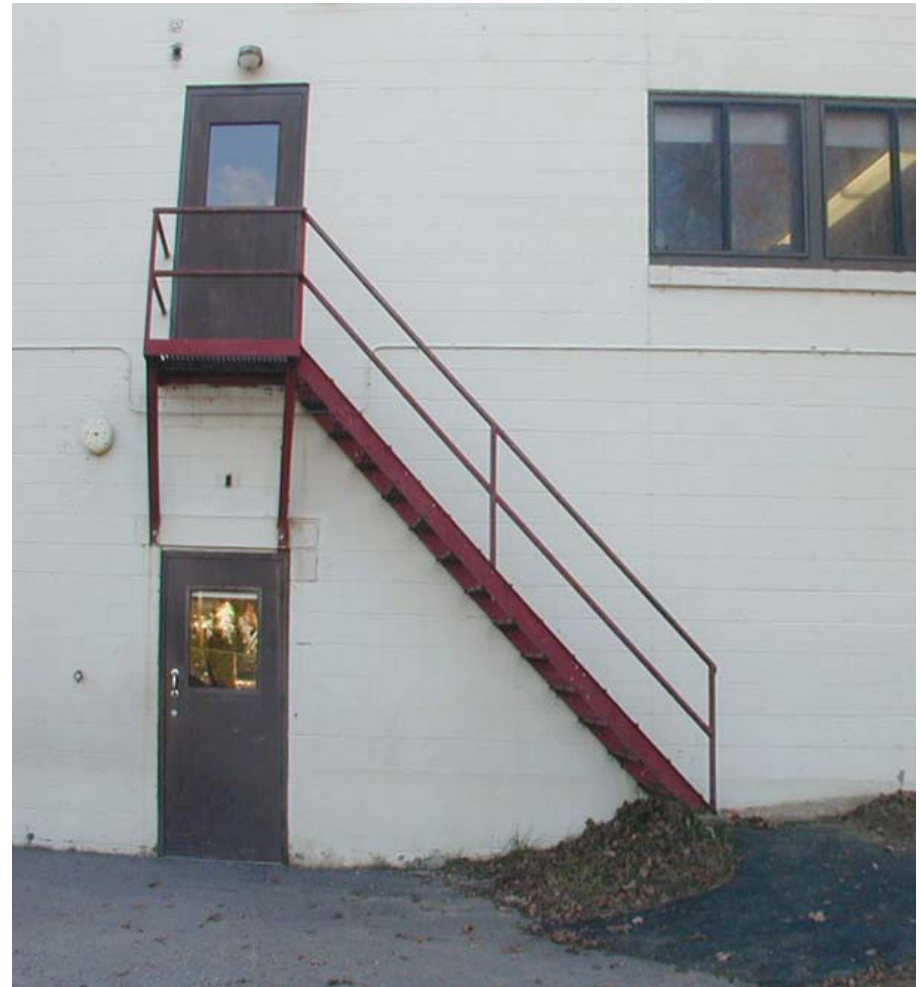
Safety Problems

- The exterior fire escape stairs is dangerous, and must be replaced with a safe, enclosed stairwell.

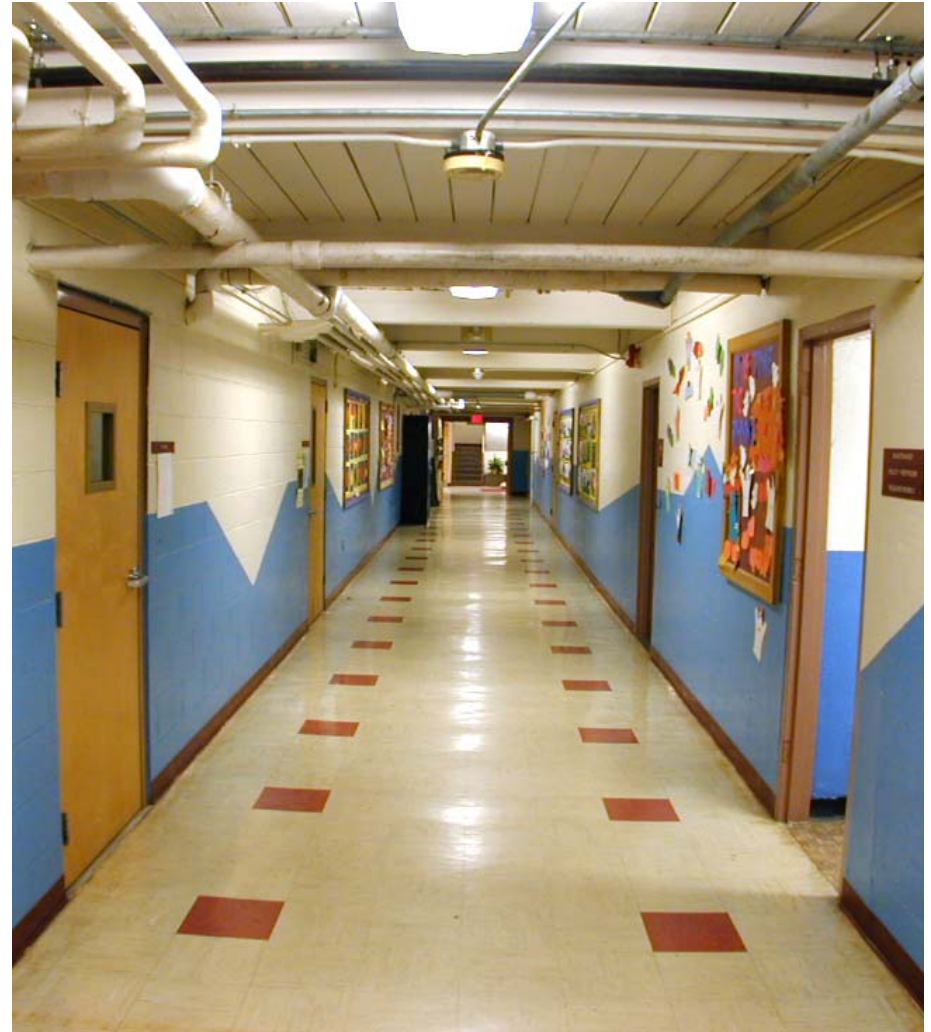
Safety Problems

- Existing exposed wood decking does not comply with code requirements intended to prevent **flame-spread and smoke-development in exit corridors.**

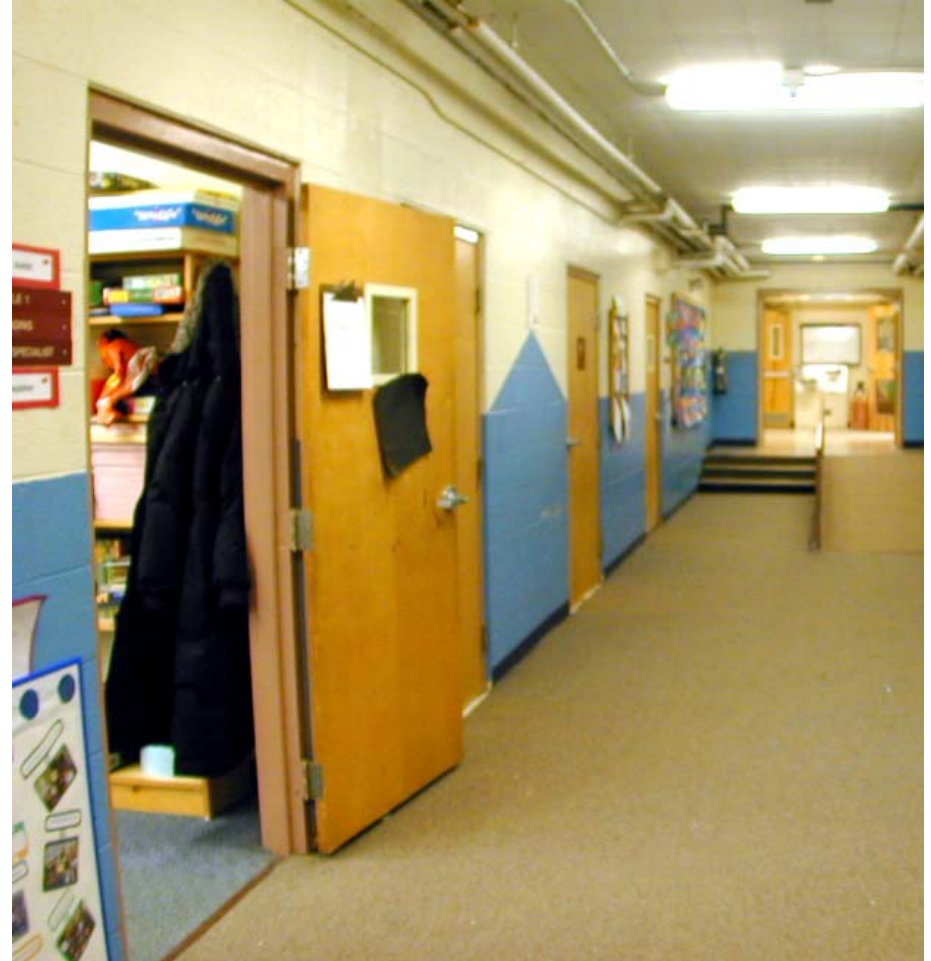
Safety Problems

- Corridor walls need to be 1/2-hour rated with protected openings.
- Corridor doors are required to be 20-minute fire doors.
- All fire doors (rated wall or smoke barriers) are required to have automatic closers.
- Several existing corridor doors are hollow core, and most corridor doors do not have automatic closers.
- Some corridor doors do not comply with accessibility requirements.

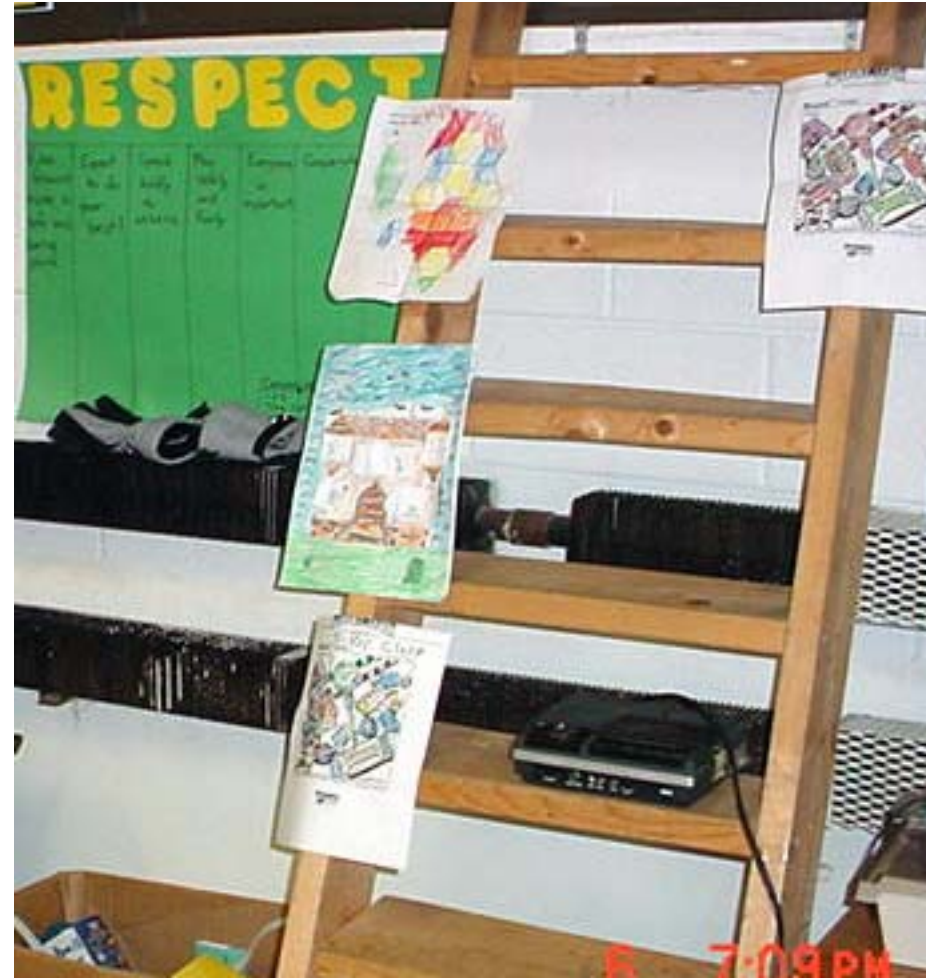
Safety Problems

- Many classroom window sills do not comply with requirements for emergency rescue window, making them inappropriate for the education of young children.

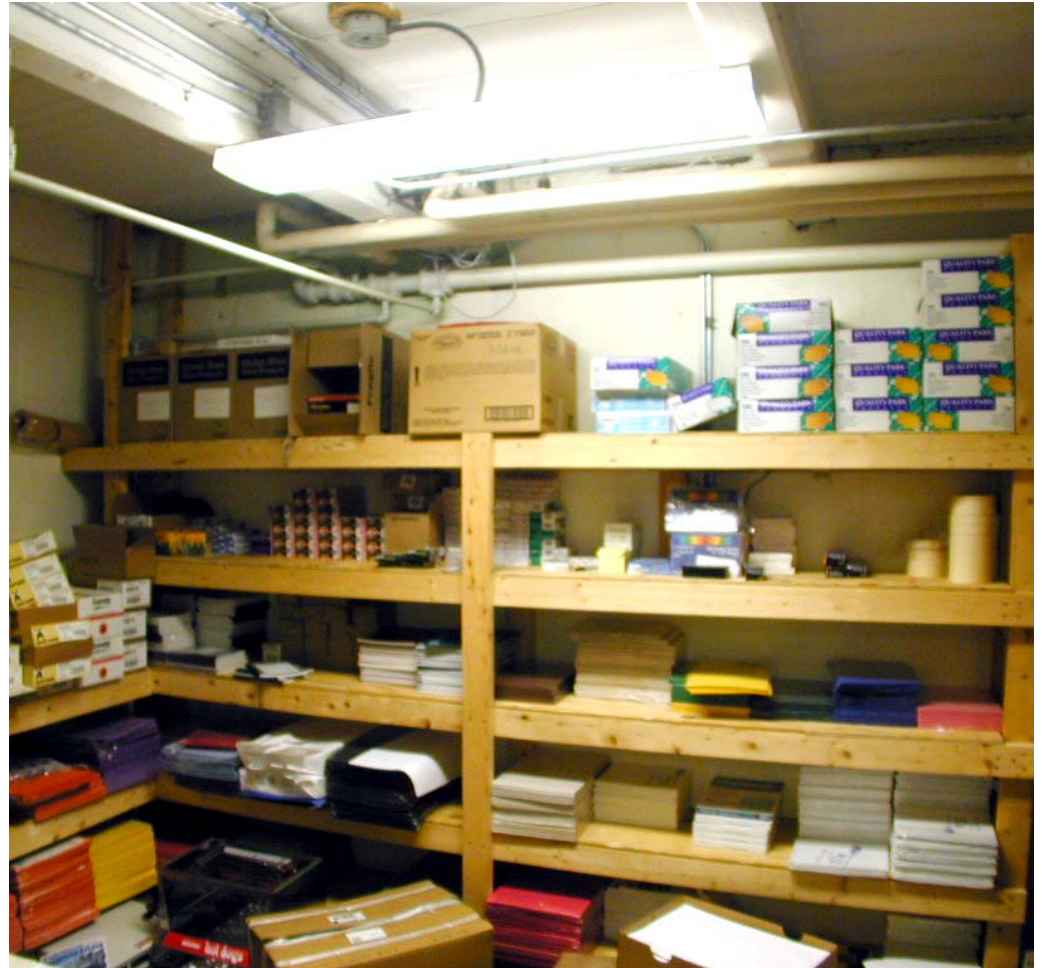
Code Problems

- The building lacks significant storage area for lightweight combustibles.

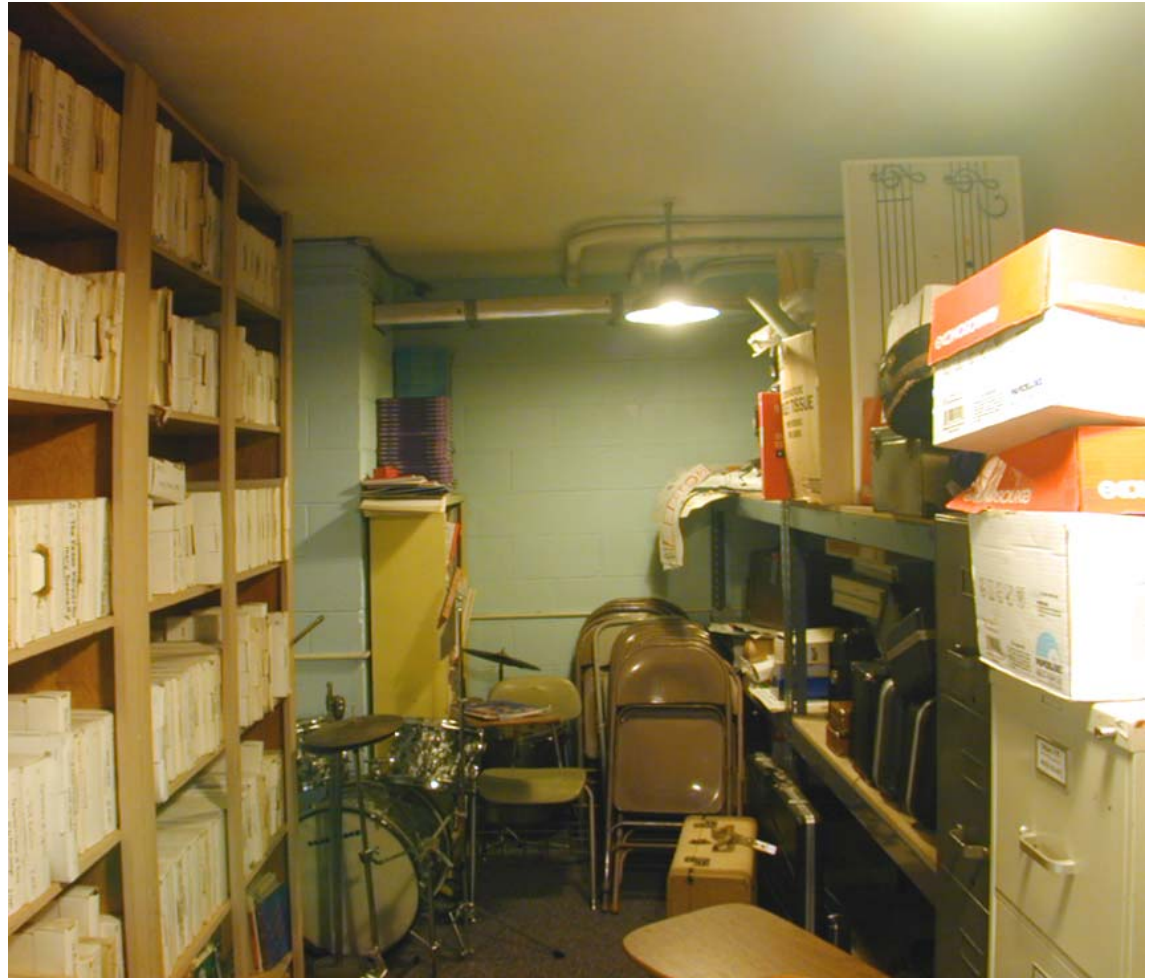
Code Problems

- The building lacks significant storage area for lightweight combustibles.

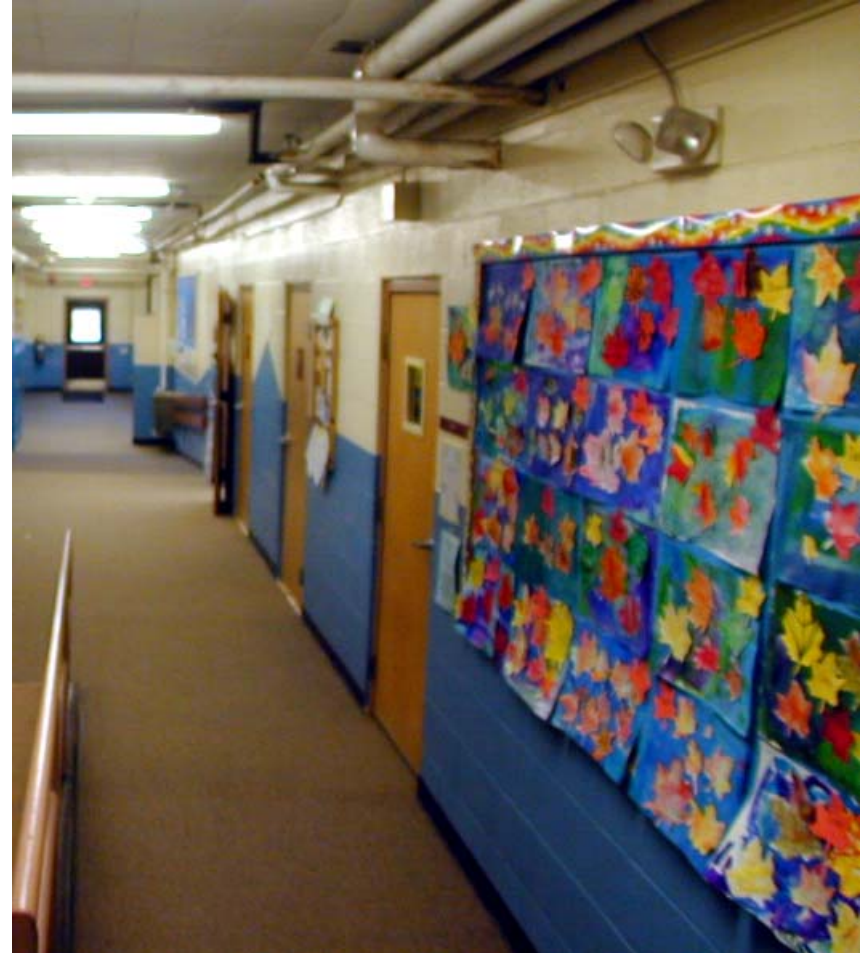
Code Problems

- Without defined storage areas and display areas, artwork and teaching material in rooms may exceeds 20% of wall area as permitted in a building that with no sprinkler system.

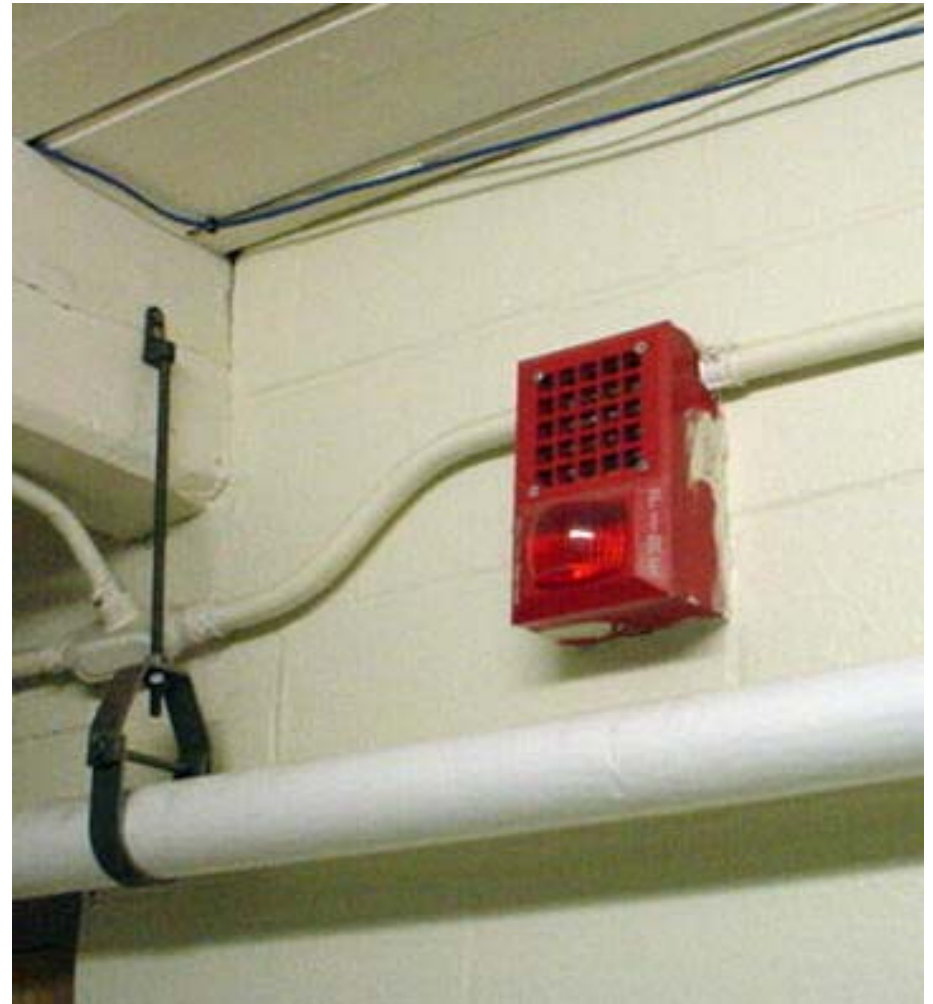
Outdated Alarm System

- Fire alarm system is outdated and does not comply with current codes for new construction.
- Older horn light units with red lenses do not comply with current codes for fire alarm visual appliances.
- Pull stations are typically higher than current codes standards allow.

- Options exist to attempt to upgrade but engineers recommend a completely new self-contained fire alarm system be provided with current-technology analog addressable devices.

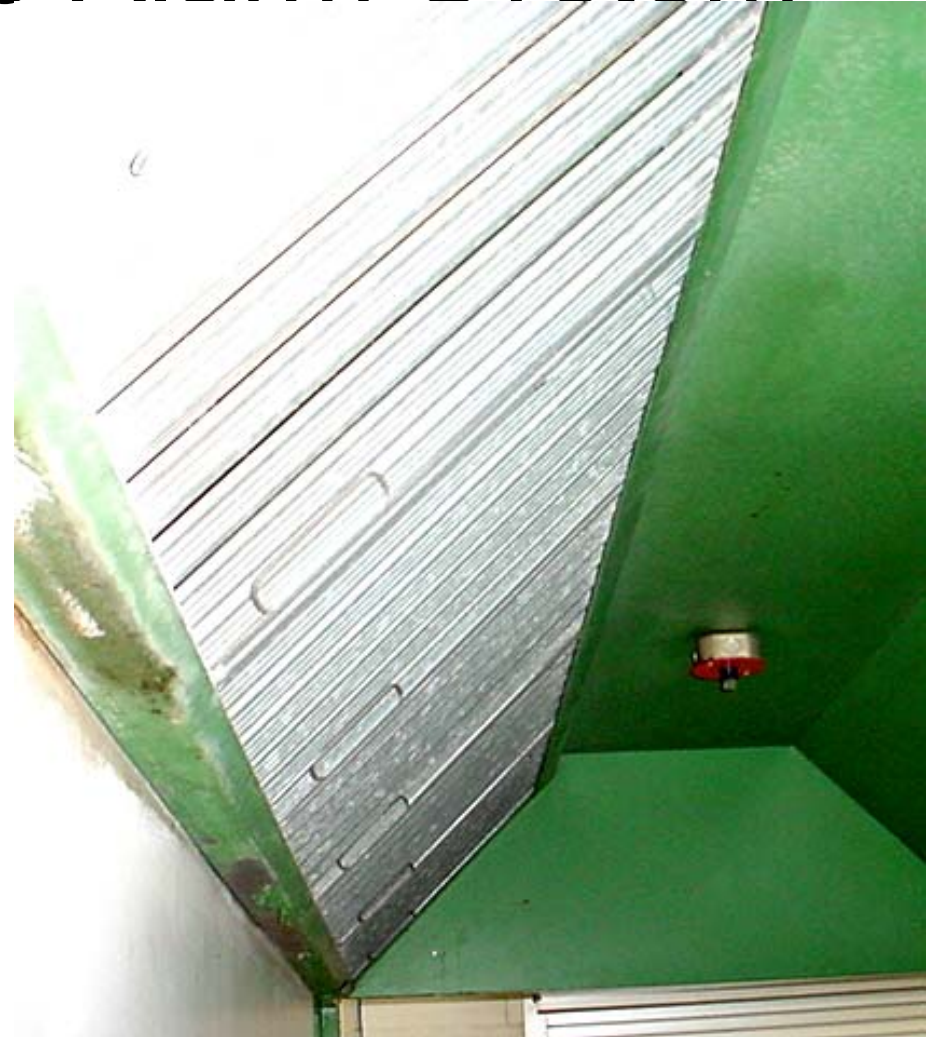
Incomplete Fire Alarm System

- There is no kitchen hood suppression system and no fire alarm connection to a kitchen hood suppression system.

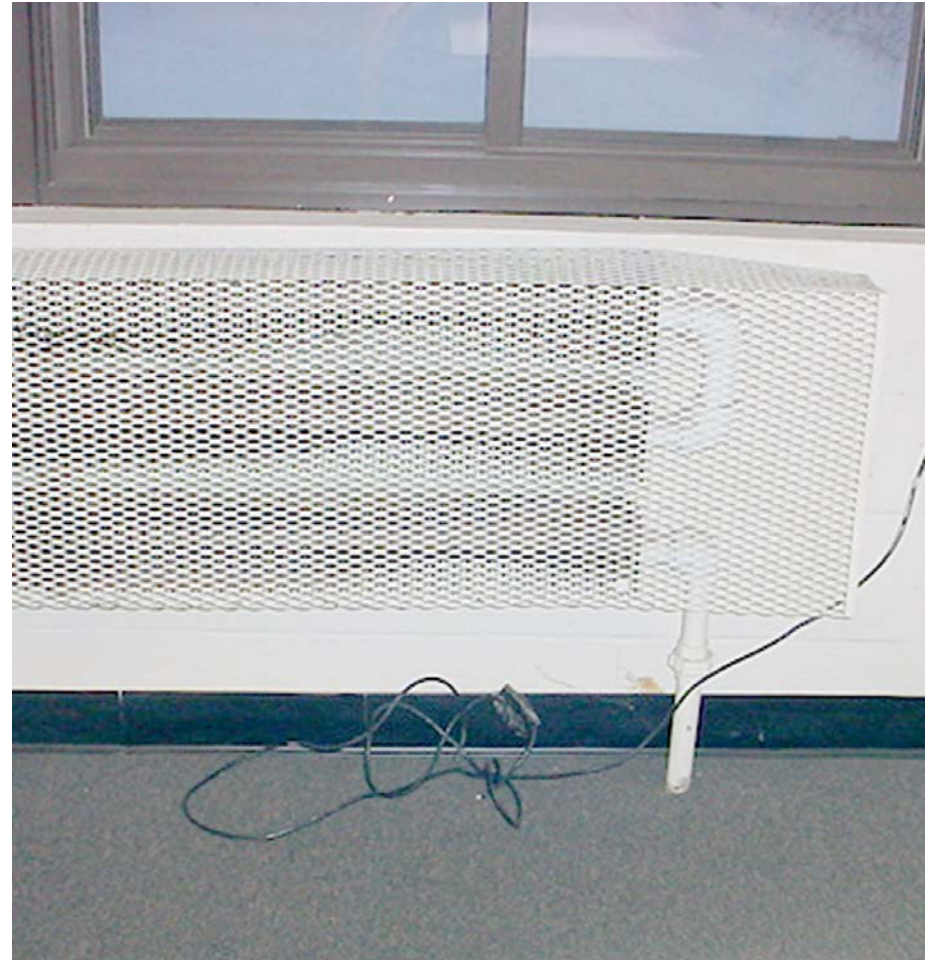
Heating/Ventilating

- The schools heating and ventilating system, is **old outdated and performs poorly**. It is universally seen as a problem.
- **Ventilation inadequate** to support a comfortable learning space
- **Temperature control inadequate** to support a comfortable learning space

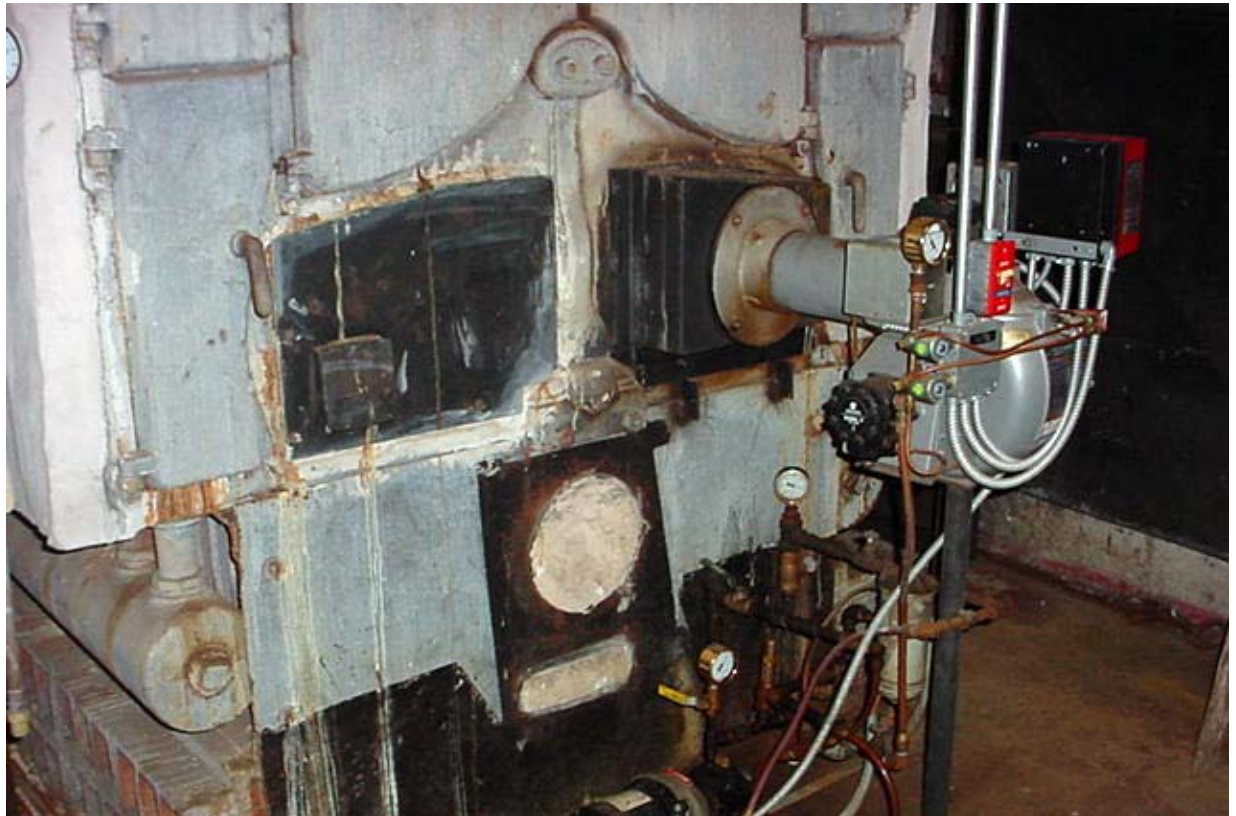
Heating/Ventilating

- The schools heating and ventilating system, is **old, worn-out and performs poorly**. It is universally seen as a problem.

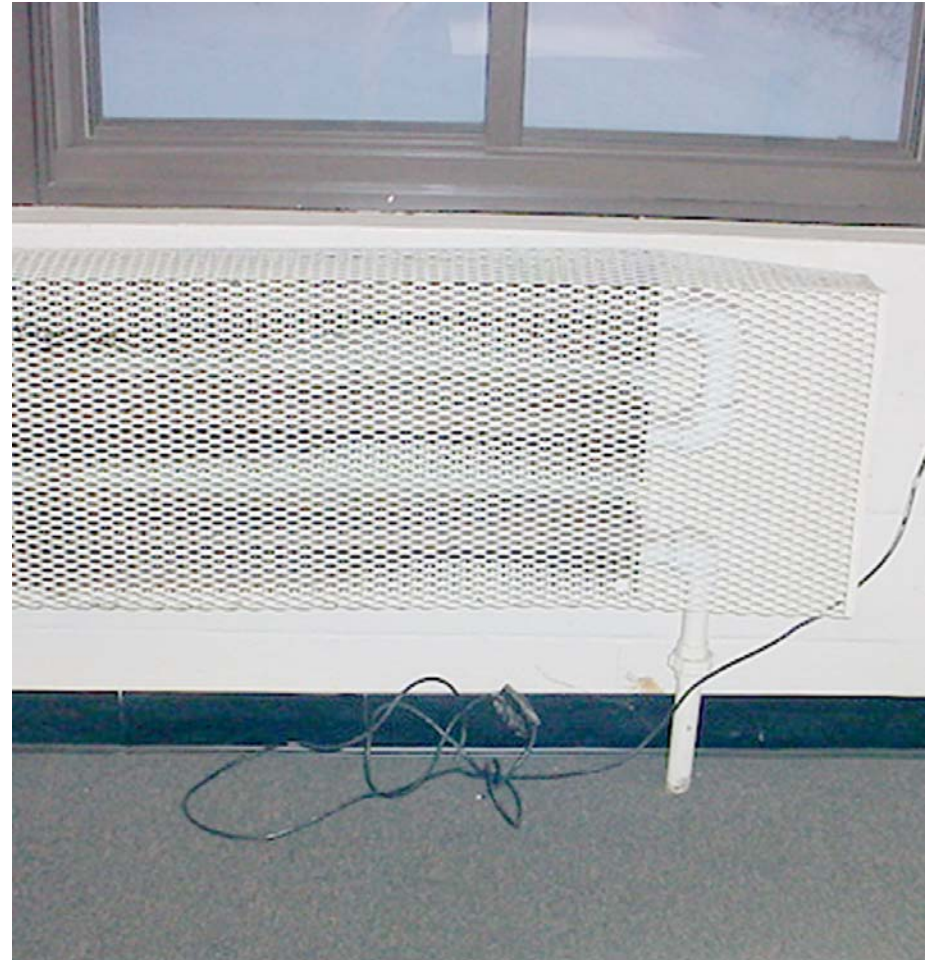
Heating/Ventilating

- **Ventilation inadequate** to support a comfortable learning space
- **Temperature control inadequate** to support a comfortable learning space

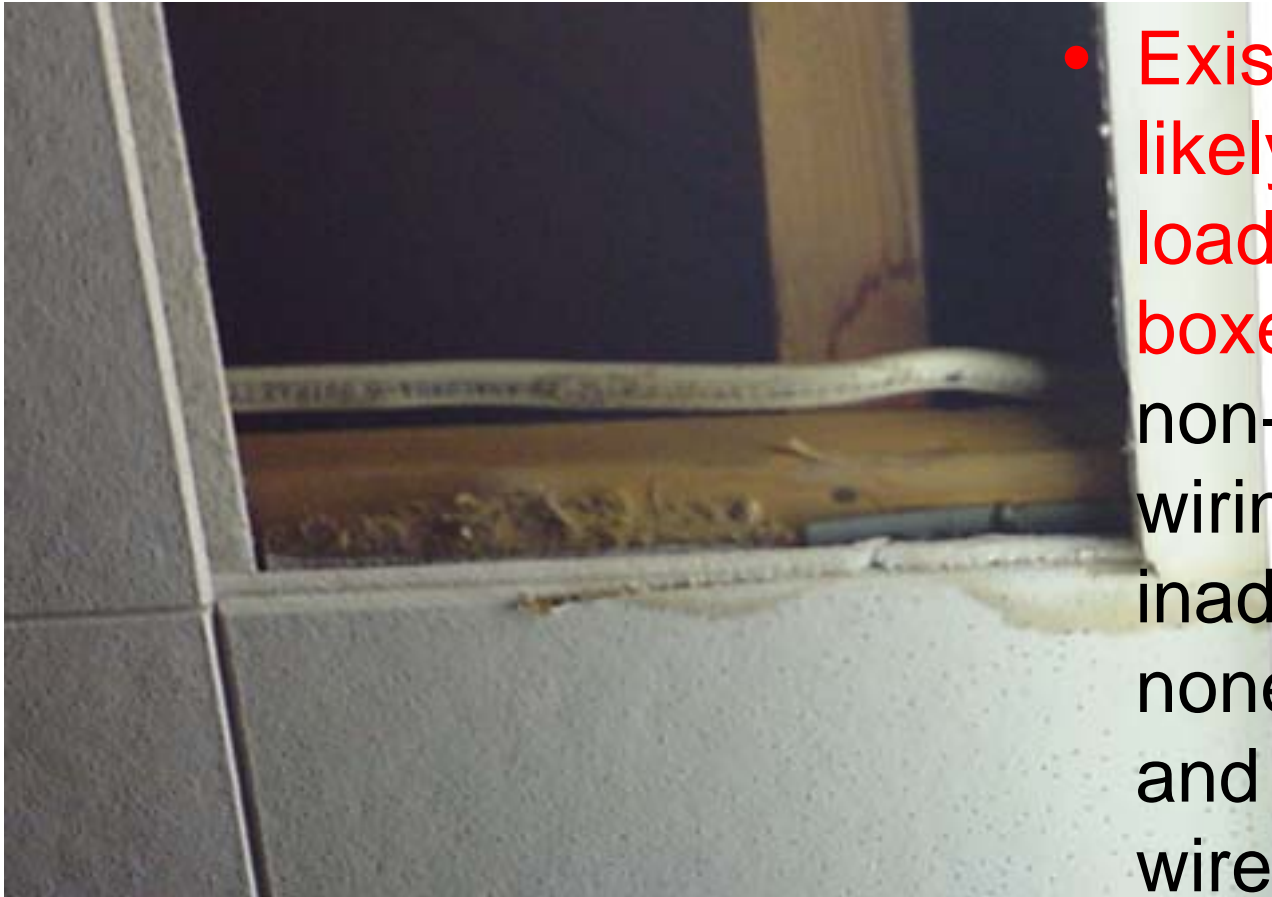
Branch Circuits

- Existing conditions likely include overloaded junction boxes, inadequate or non-existent ground wiring, and inadequate or non-existent conduit and cable support for wires above ceilings.

- **Renovations will trigger code issues** (electrical systems, or related mechanical work or owner equipment work which calls for new electrical circuitry, or architectural work including removal and replacement of presently exposed ceilings or original ceilings above the suspended ceilings.)
- **Recommend replacing the branch circuit wiring within the building completely.**

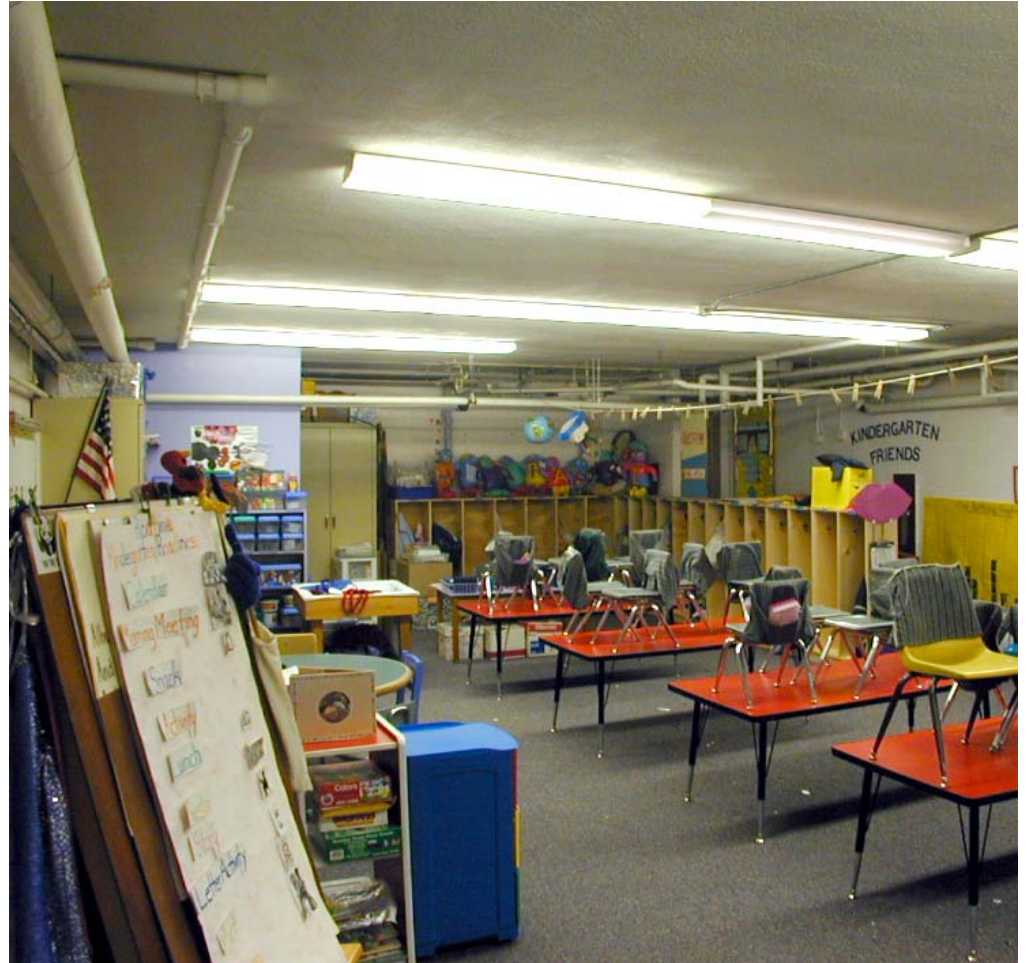
Classrooms

- Comparatively, Marlborough classrooms have
 - harsh lighting
 - poor ventilation
 - little natural light
 - Inflexible spaces
 - little sound control
 - are unattractive

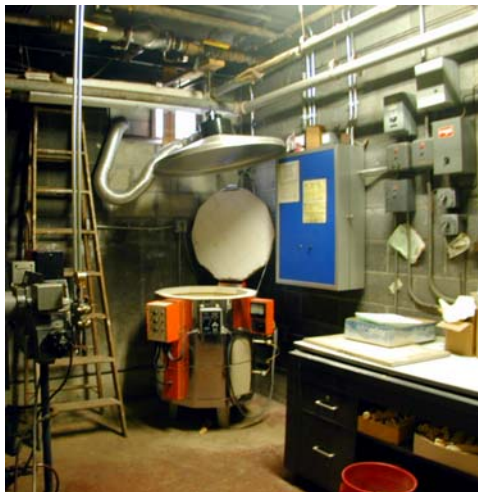
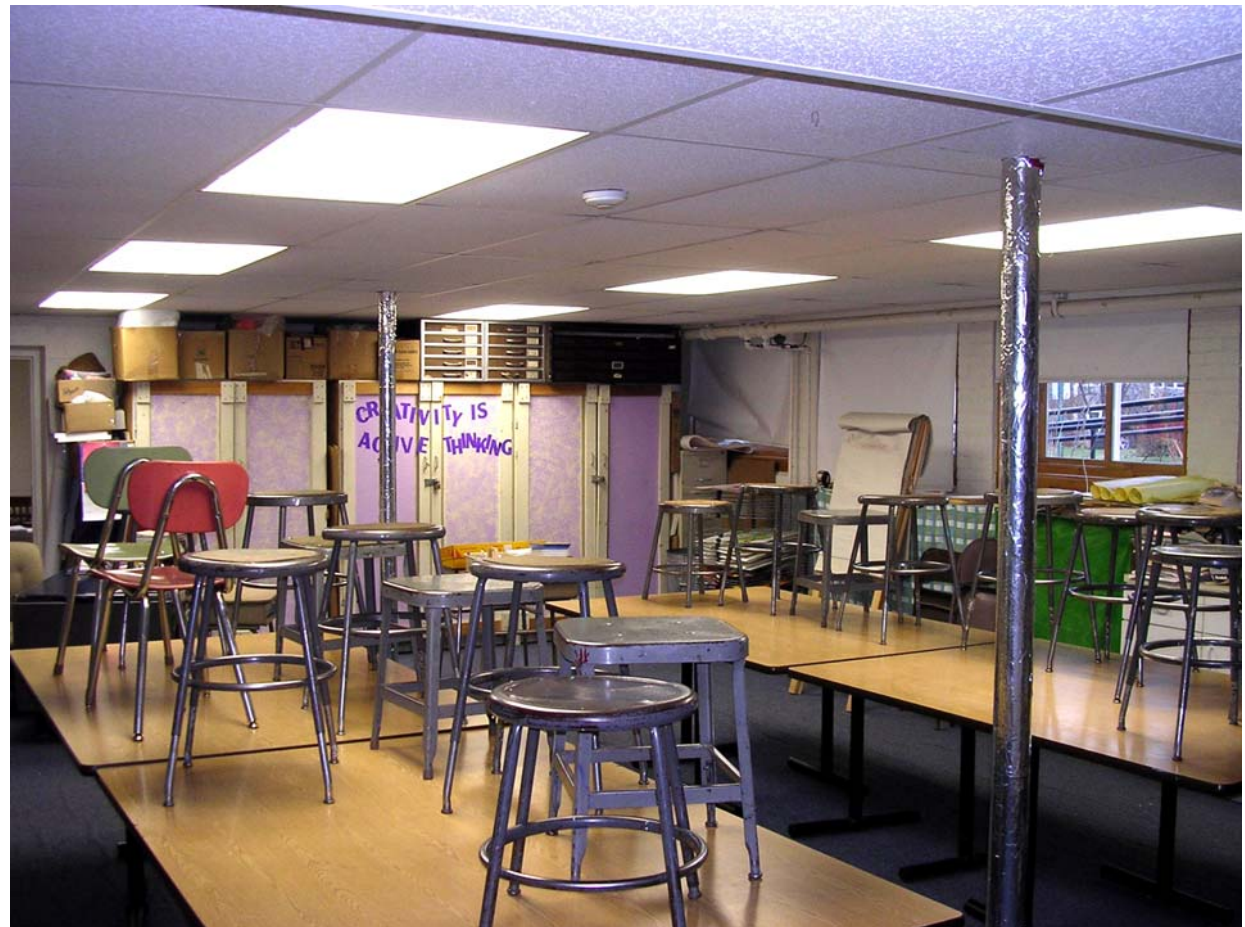
Lower Level Problems

- Art Room
- Kiln Room

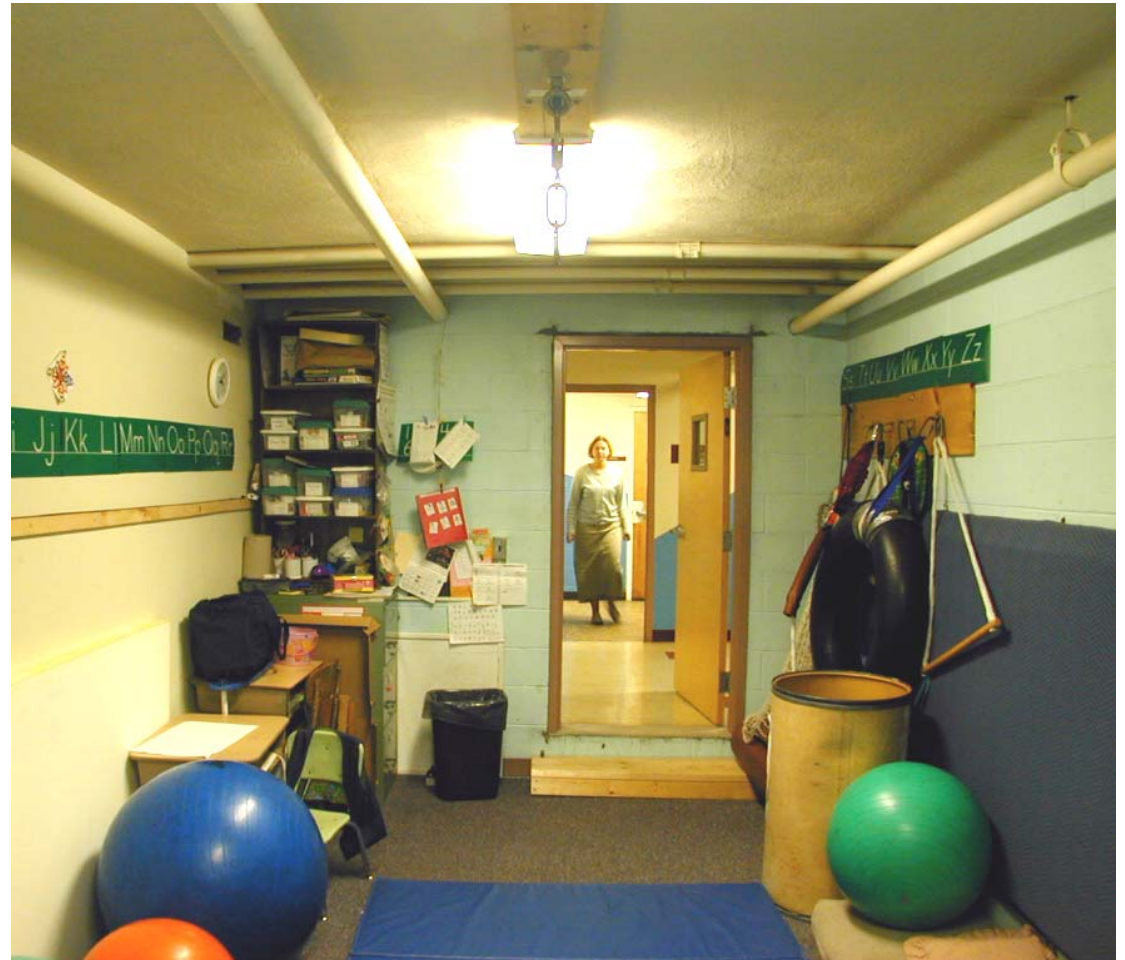
Lower Level Problems

- Necessary and mandated educational functions that didn't exist in 1974 are accommodated in substandard space.
