Town of Marlborough Marlborough, NH

Stormwater Infrastructure Planning and Evaluation Report

July 2023

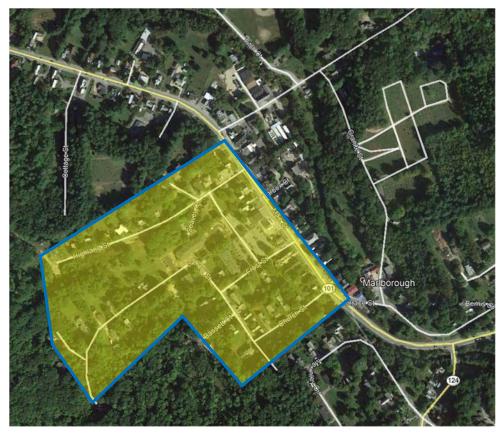
Figure 1 - Project limits.

Gale Associates, Inc. (Gale) was engaged by the Town of Marlborough to perform a feasibility study of the existing drainage system in the Church Street, School Street, Frost Street, Pierce Avenue, and Ling Street area of downtown Marlborough, NH. The project area (refer to Figure 1) was identified in the Town of Marlborough Wastewater Collection and Stormwater System Asset Management Plan (AMP), dated August 2020, as a critical area that required further study and improvement.

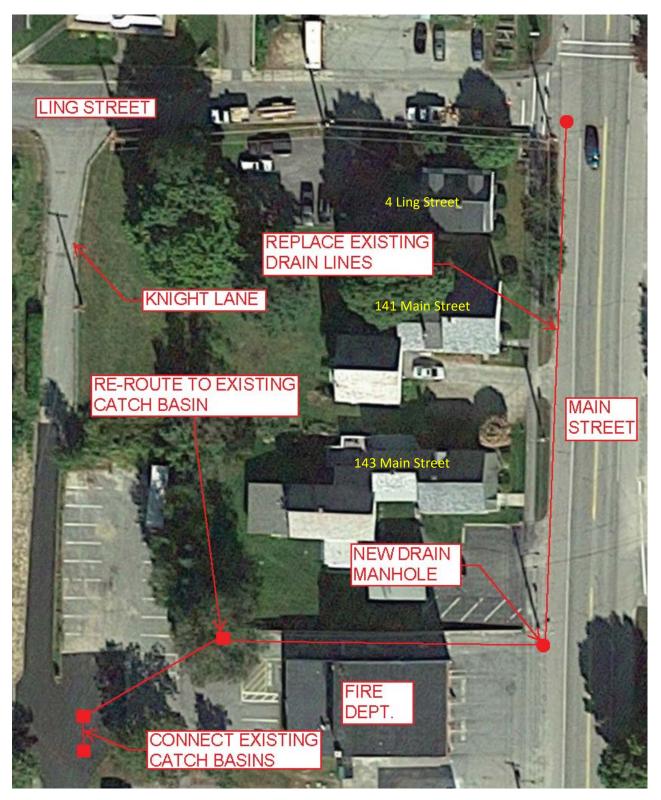
This alternative was modeled in SWMM to evaluate the performance relative to the existing system. The connection would consist of new 30" RCP. The existing catch basin on Knight Lane (Node 0198) will connect via a 12" RCP to the existing catch basin (Node 0205). Proposed pipes have sufficient capacity to handle the July 18th storm event. The existing NHDOT drainage pipes downstream of the proposed connection to the NHDOT system are 15" and 24" pipes. To accommodate the increased flow, the existing pipes will need to be removed and replaced with a new 30" RCP.

Figure 9 - Alternative #3b layout.
